Appendix 14.5 Geophysical Report

Foynes to Limerick Road Improvement Scheme, Co. Limerick

Archaeological Geophysical Survey

Detection Licence No. 18R0122

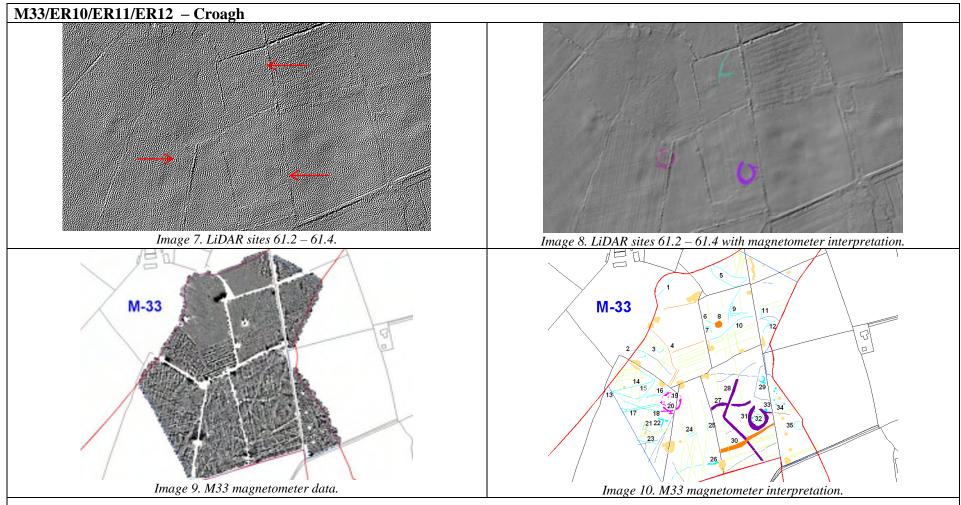
The LiDAR anomalies were confirmed through magnetometer and resistivity surveys as being associated with two enclosures. The northern enclosure appears to be bivallate and contains a very slight topographical expression located on the inside of the inner enclosure ditch, which may be a bank. The same form of topographical expression can be seen in the southern enclosure; however, this feature appears to be surrounded by a single enclosure ditch and encompasses a portion of the extant field boundary.

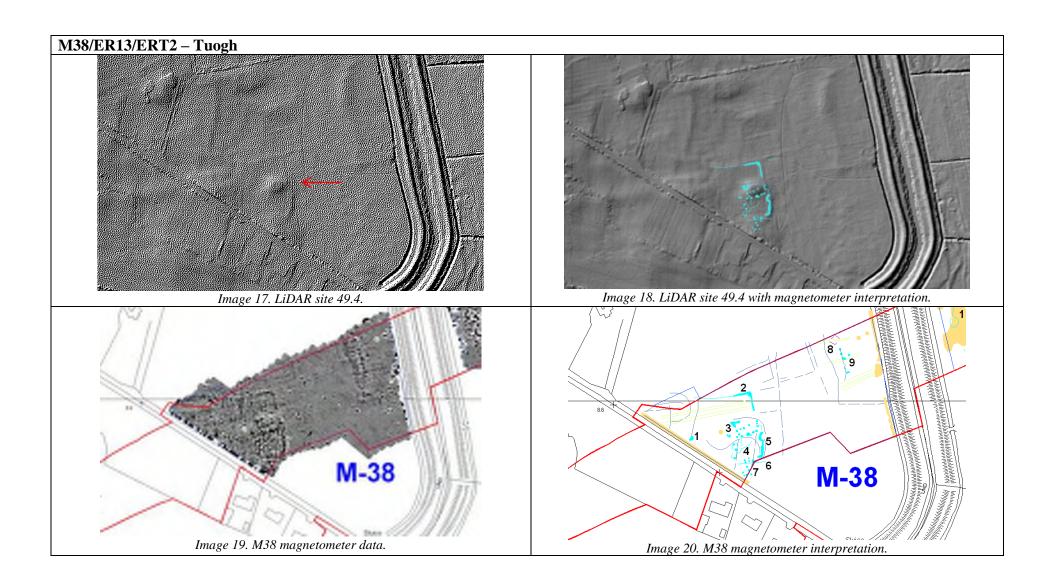
The majority of the archaeology appears to be covered by approximately 0.50m of soil and survives to a depth of 1.5m below the modern surface. It is likely that the feature seen within the LiDAR and visible as a topographical feature within the field represents a banked enclosure, possibly surrounded by an outer ditch. Within this enclosure a number of possible habitation sites have been found which are divided and dissected by a number of ditches or cut features. Although the apparent depth of the archaeological remains is unusual it is possible that the site has been covered in soil deposits or is contained within a depression which has naturally in-filled.

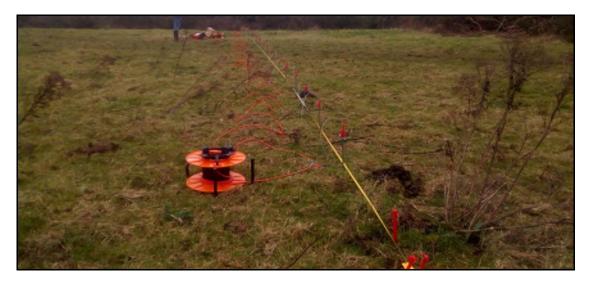
Plate 13&14: Unsurveyable ground conditions in part of M39/ER14
